*MINE WATER AND THE ENVIRONMENT, VOL. 14, ANNUAL ISSUE, PAPER
9, 1995, PP 107- 130*

Mine Inundation-Case Histories

V.S. Vutukuri * and R.N. Singh**

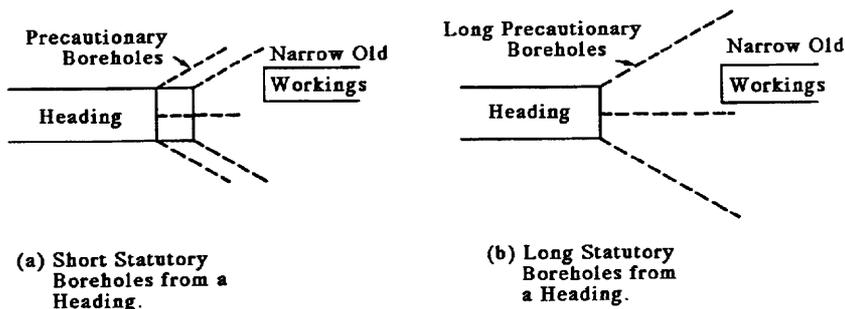
- (i) Short advanced bore holes may leave an inadequate barrier between the blind end of the bore holes and the old workings which may subsequently fail (Figure 1).
- (ii) Long advanced bore holes may completely miss a narrow old workings containing an accumulation of water.
- (iii) An advanced bore hole through highly stressed ground or an outburst prone ground may completely close due to strata pressure thus giving wrong impression that the old mine workings are free of water.
- (iv) There are no statutory provisions for controlling the inflow of water through precautionary bore holes once they have intersected the old workings.

Figure 1 Statutory bore holes when current workings approach water logged workings

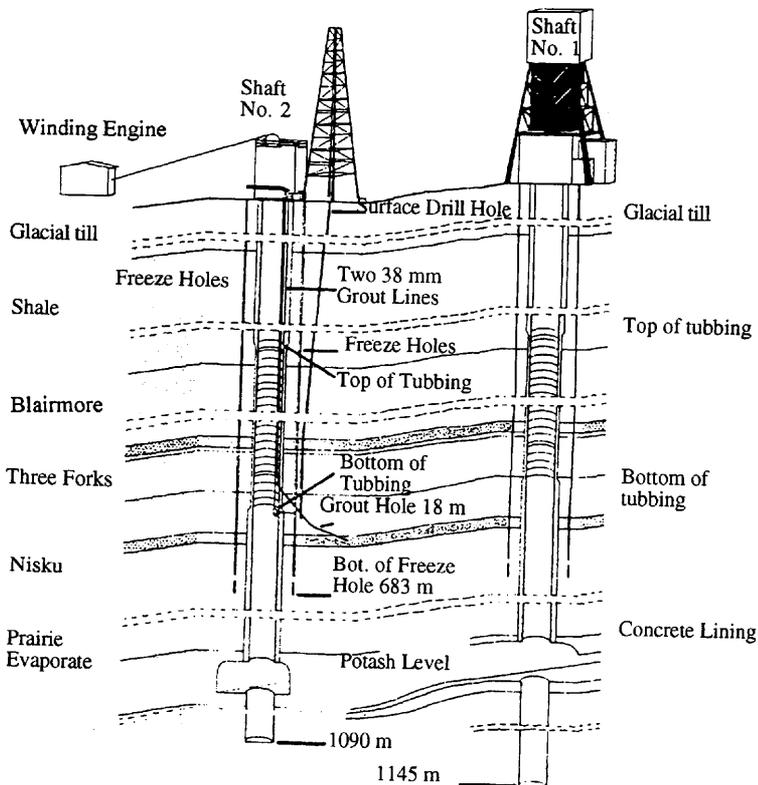
Figure 4 Section through No.1 and No.2 Shafts, Cominco Potash Mine (Prugger, 1979)

On 2nd August, 1970, during routine shaft grouting, a major water feeder was intersected at the bottom of the tubing column. Water and quicksand under very high pressure entered the shaft at a rate of 65 m³/min (1083 l/s, Prugger, 1979) and flooded the mine including both shafts. Figure 4 shows the cross section through both shaft showing stratigraphical column and the point of intersection.

The breach was sealed with cement grout simultaneously from and within the shaft through a relief hole drilled from the surface. The mine was dewatered, rehabilitated and the equipment was restored and the production resumed two years after the accident. A total of 515,130 m³ of brine had to be removed before clean-up and rehabilitation of underground mine openings and equipment could begin. To provide access to the mine, 15,000 m³ of fine quartz sand and mud had to be removed. One low-lying area was not dewatered, but was abandoned.

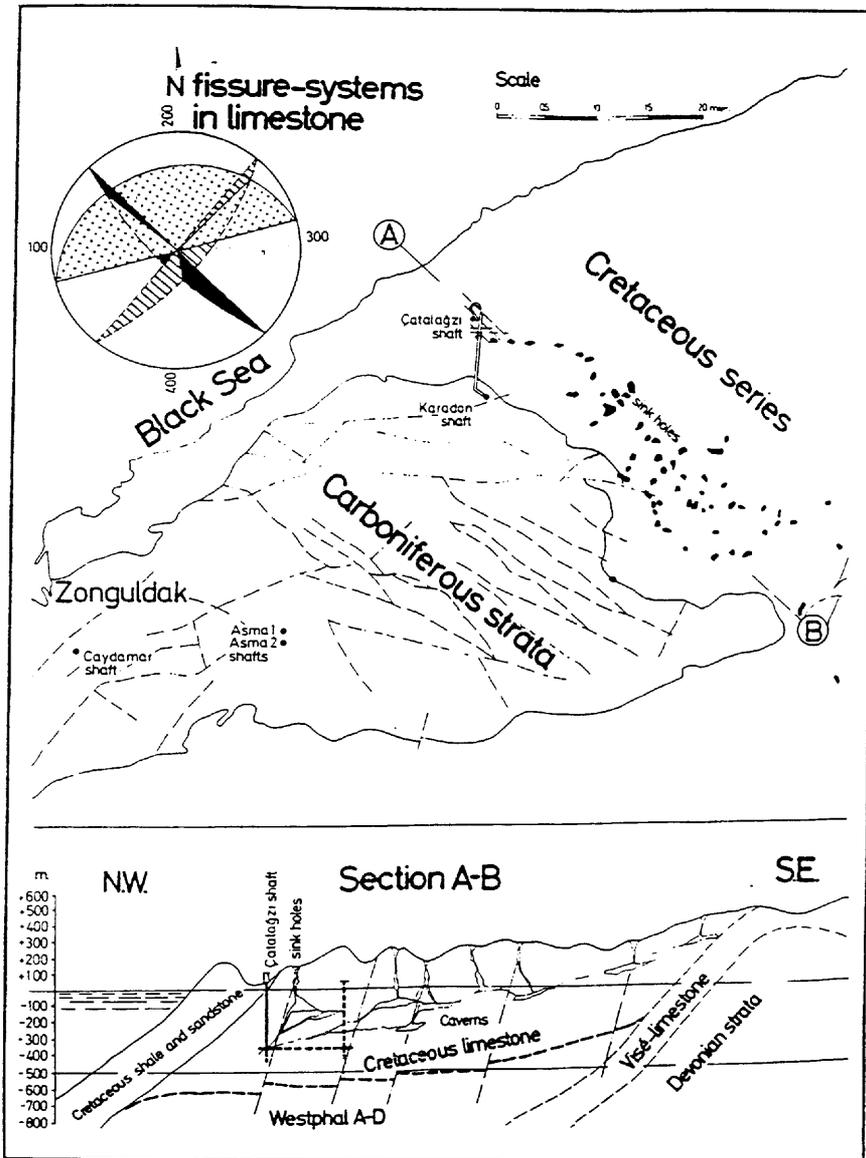
The Catalagzi shaft had an inside diameter of 6.5 m and was concrete lined. As the shaft was sunk through the karstic limestone, extensive grouting work had already caused a delay of 18 months during the sinking due to constant water problems. After sinking was completed the underground loading station loop had to be driven through the vuggy, water bearing limestone and the shaft station had to be connected with the existing mine workings by a main haulage roadway through limestone which dipped at about 30°. The development work was carried out observing all precautions. Pilot holes were kept in advance of the face and the rock mass was grouted where necessary. After 300 m of drifting through the karst limestone in the loading station loop, a major water inflow occurred. It can be seen in Figure 5 that the karstic limestone forming the basin has many solution caverns and is intersected with major faults. It may also be noted that in spite of these hydrogeological features there were no test holes drilled in the vicinity and at the centre line of the shaft at the time of shaft sinking. During the drive of the loading station loop, water rushed in at a rate of 32.5 m³ per minute. As a consequence, the drift was completely flooded and had to be abandoned.

Figure 5 Geological structure of site 2 in the vicinity of Karadon and Catalagzi shafts (Mattes, 1975)

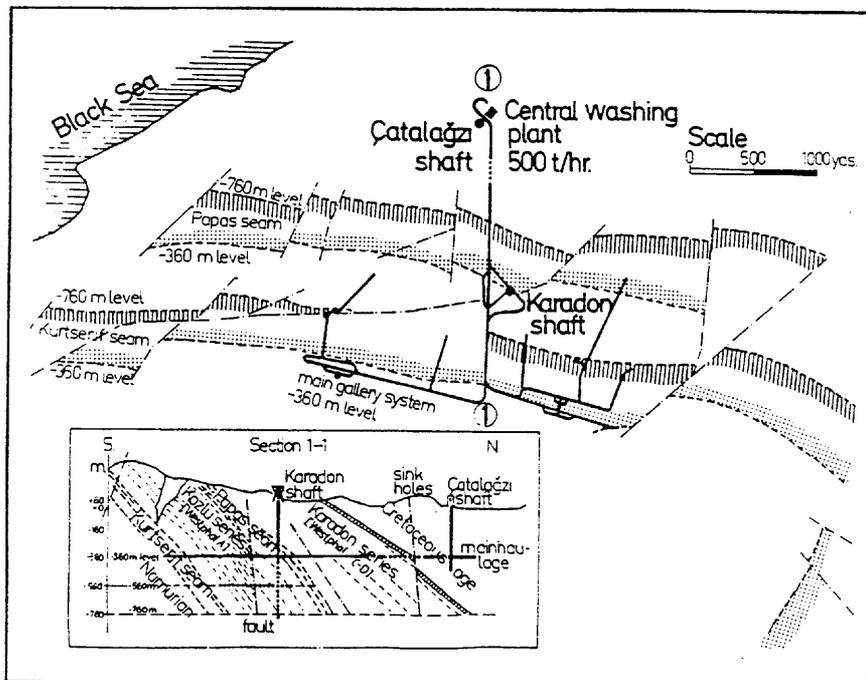
Figure 6 Plan and section of Karadon and Catalagzi section (Mattes , 1975)

The Catalagzi shaft subsequently filled up with water to a level of 16 m below the shaft collar. The shaft was then dewatered by using 11 stage submersible electric pumps with a capacity of 7.2 m³/ min. It may be noted that the help of a diver was needed to remove shaft debris. After two and a half years and four major floods the shaft was secured by a water dam 120 m north of the shaft. In order to isolate the major feeder intersecting the karst aquifer concrete water dams with watertight welded steel doors were required to seal the water feeder. A second water dam was also built on the south side of the shaft and equipped with a water tight door. Only after the shaft had been protected by these dams, the mining of the main haulage to the Karadon mine started. It required 2½ years using 11-stage submersible pumps and at a cost of \$1.6 million to dewater the mine.

The lessons learnt from this case example are that geological and hydrogeological studies are necessary requirements for major development projects in coal mining. An advanced bore hole should be drilled at the site of major shaft and underground main development headings.

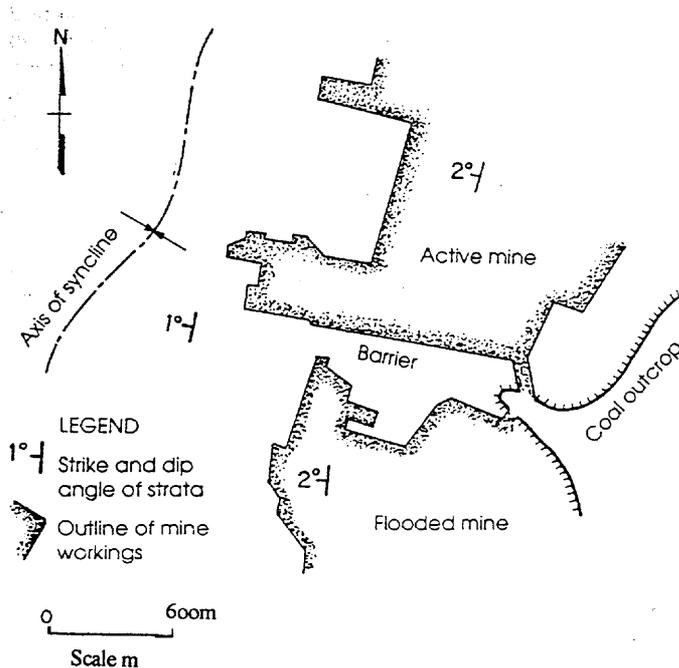
In this mine a barrier of apparently more than adequate dimensions failed to prevent a substantial influx of water from the adjacent flooded mine. Water first entered through roof-bolt holes and slickensides in the roof with only minor seepage through the coal seam. Analysis confirmed that the seepage was mine water rather than ground water. Dewatering the flooded mine was estimated to take a minimum of 180 days continuous pumping at a rate of (63 l/s) without allowing for any recharge.

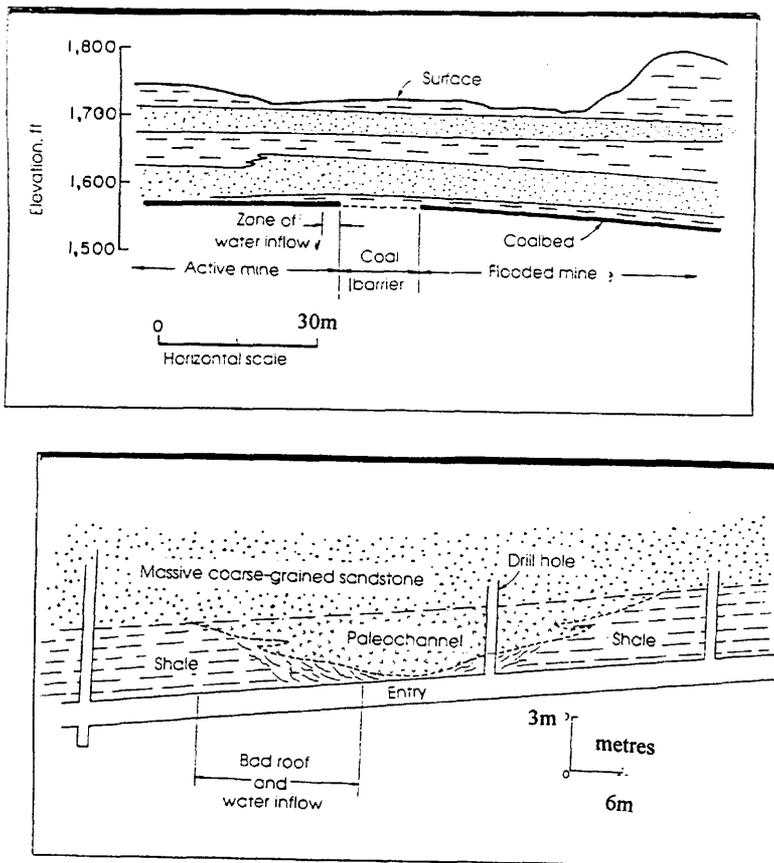
Three bore holes drilled in the mine roof and one from surface revealed a sandstone-filled paleochannel (Figure 8a and b) adjacent to the zone of heavy water inflow. Pathways for the water lay along the margin of the channel where deformation of the roof strata had occurred. Although no evidence was obtained which could confirm the

Figure 8 (a) Transverse profile of the barrier zone (b) Paleochannels in the roof strata of the active mine.

continuity of the paleochannel across the entire width of the barrier, no explanation other than an anomalous, permeable geological structure seemed warranted.

This case example demonstrated that the barrier pillars between the water logged workings and the active working should be free of geological structures and anomalies.

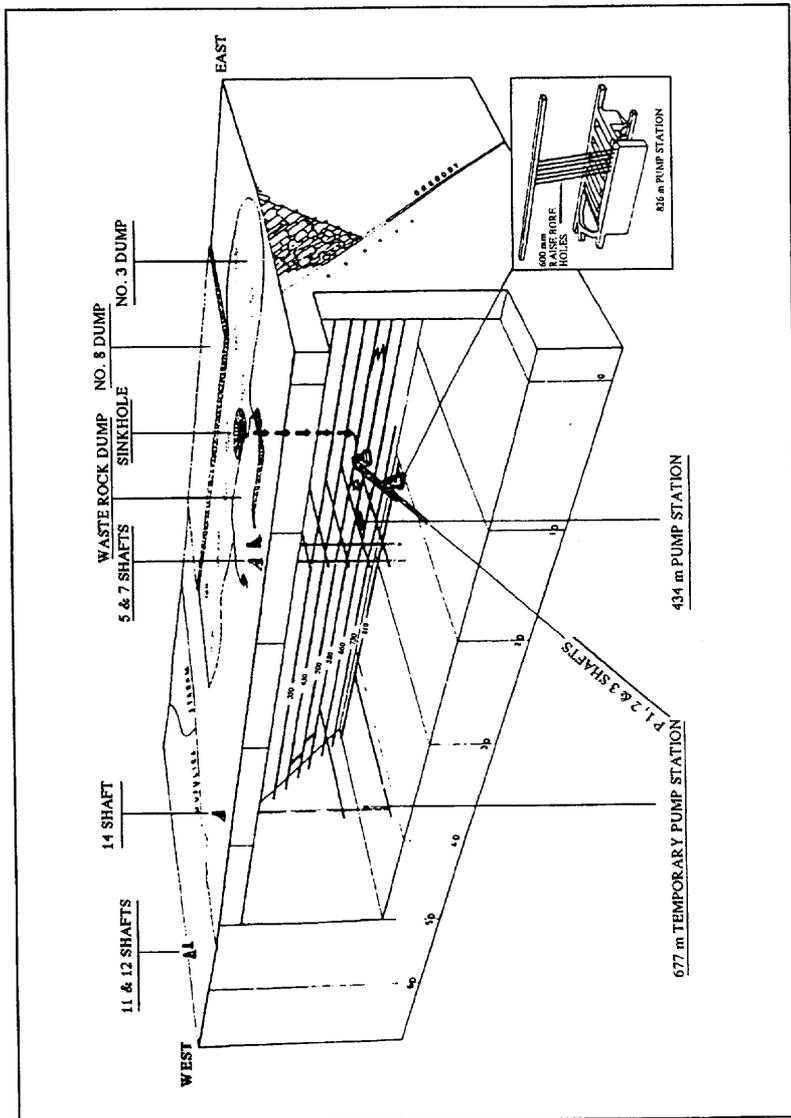
On September 30, 1970, a sink hole appeared on the surface through which a mud flow, composed essentially of concentrator tailings, poured into the mine, killing some 89 miners and causing serious damage to the mine. Within a 15-minute span in the early-morning hours of 25th September, 1970, an inrush of about 453,070 m³ of mud from the surface flooded much of the Peterson section of the mine, trapping and killing miners and wreaking extensive damage to the mine itself (Figure 9). The bulk of this mud originated from a large accumulation of saturated tailings from the concentrator, which had been impounded on subsiding ground above the mine workings. A sinkhole with an associated collapse chimney developed beneath this accumulation, creating channels leading to the underground workings; through these channels, tailings flowed into the mine through several major ingress points between the 500m and 580m levels, and thence to lower levels via ore passes, raises, and the Peterson shaft system. As a result, the Peterson section filled with mud and water from the 500m level downwards.

This inflow of water and mud was a case of accidental inundation unprecedented in the history of mining. The risk associated with bad mining procedures and geotechnical instability of backfill could not be foreseen by the mining officials as well as the government inspectorate. Erroneous beliefs, poor communications and lack of engineering judgment can be attributed as the basic cause of the disaster.

Figure 9. Mufuira inrush area showing position of shafts, main levels, pump stations, and the sinkhole on the surface with the probable entry point of the mud and tailing into the mine workings. The inset shows the arrangement for introducing submersible pumps into the sumps (after Neller et al., 1973)

This disaster proves that before starting a new scheme it is prudent to carry out a risk assessment for men, equipment and process before adopting it.

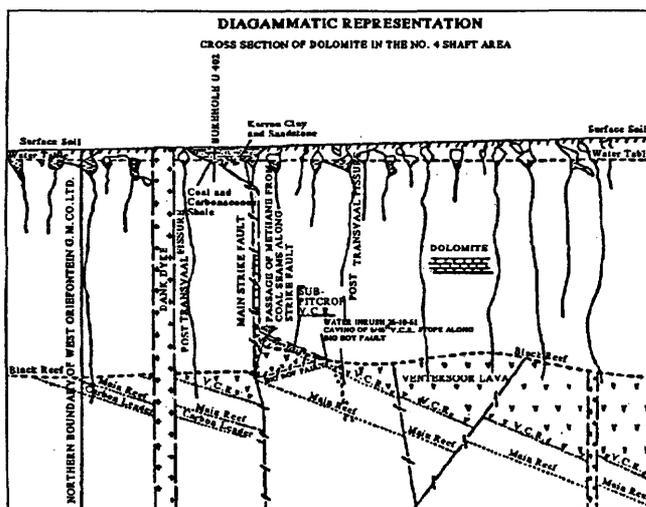
Figure 10 Diagrammatic representation of solution cavities and fissure formation (Coussens and Garret, 1969)

On the morning of 26th October, 1968, an examination of the hanging wall in a stope between 4 and 6 level, No. 4 shaft (Figure 10) at a depth of 863m below surface,

indicated some movement and a small amount of water inflow. At 9.30 a.m. a fissure opened in the stope and large quantities of water rushed into the mine.

The plan of campaign adopted after the inrush of water and the reorganization and expansion of pumping arrangements was discussed by the authors. When it became clear that the only means of saving the mine was to construct plugs to isolate the inrush, while maintaining all emergency measures, the work was put in hand at once.

In considering the design of the plugs, some major factors had to be taken into account, the most vital of which was the need for speed - which was complicated by difficulty of access to the plug site because of the huge volumes of water flowing in the drives. How this difficulty and other problems were overcome was also detailed in the paper. This incident highlights the notion that strict management system and technical expertise are necessary to detect and control ground water inflow potential when mining underneath a major karst aquifer. In addition to drilling advanced boreholes to locate a large reservoir of water, a large sump and installed emergency pumping capacity and management plan are necessary to meet such emergencies.

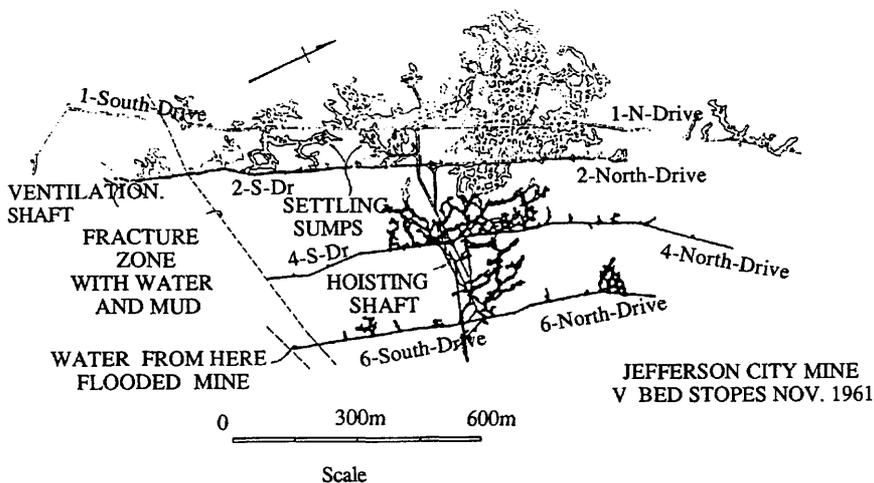
Figure 11 Cross section through Jefferson City Mine (Miller and Jolley, 1964)

On the south western part of the mine a highly fractured water bearing zone comprising steeply dipping fractures and faults with minor displacements was known to be present. Examination of the exposed fracture zone reveals a series of lenticular voids up to 152 mm in width with the rest of the zone water tight. The pattern of the voids in the plane of the fault resembled a lacy structure. Water, heavily charged with mud and sand, had been encountered within this zone by drill holes during driveage of 1-S, 2-S, and 4-S drifts. Each time the water was controlled by placing packers in the holes. Drilling of precautionary pilot holes in advance of the drift face was, therefore, unreliable. It was believed that at greater depth this zone would be comparatively dry because the fractures and voids would have tightened with depth.

In driving 6-south drift, in moderately oxidized minor fault zone, a newly exposed face intersected the known water bearing zone. There were two or three small lens shaped voids up to 102 mm wide along the fault plane which yielded some 4 to 7.5 l/min of water. The water potential of this fracture zone was under-estimated and proved to be far in excess of any previously known in the district. On 7th November, 1961, a night crew started drilling a round in 6-S drift 472 m southwest of the shaft crosscut and 372 m below the surface, when the drift hit watery ground. Their jumbo had 3 drills which were simultaneously drilling the first bore holes, all 32 mm in diameter. Four 4.3m pilot holes drilled in advance of the previous round had not encountered water. The left bore hole and the central hole had reached a depth of 2.4 to 2.7 m. At a depth of about 0.9 m, the right bore hole encountered mud and water. Initial inflow was estimated at 19 - 26 l/s at an approximate pressure of 3.1 - 3.5 MPa. The first attempt to insert a packer was unsuccessful due to a lack of clearance between the packer and the hole, and as a consequence a leak developed in the packer. Subsequently, another packer was inserted and the water shut off for about 4 hours before a leak developed. The abrasive sand and mud badly eroded the packer, culminating in complete failure 8 hours later. All further efforts to secure a packer in the hole were unsuccessful due to

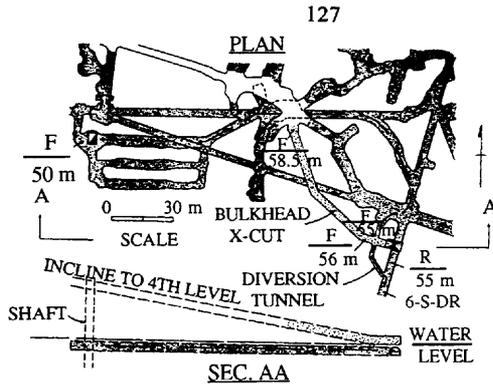
A: Development (stipled area) for 6-S plug required driving a 81 m cross-cut an 25 m diversion tunnel that connected with 6-S drift. Shaded areas represent working full mud

At this point of time, it was decided to build a friction type plug at 6-level South to seal the inflow. To achieve this end, a plan was devised for plugging off the 6-S drift without the need to lower the water level below a 55m datum viz. 6 m above the 6th level station. This plan involved building a large concrete plug in the 6 level south drift from the top of the drift and a small concrete plug with valved pipes in an adjacent diversion tunnel. Both plugs were the friction type with no hitches or reinforcing steels except for some steel pins in the diversion plug. A crosscut 82 m long was driven from a stope which had been cleaned of mud at elevation of 57m, to a point 1.5 m above the back of 6 level south drift. At the elevation of 55m, a 1.8m by 2.4m diversion tunnel 25 m long was then driven both north and south to within one round of connecting with the 6 level south drift. The elevation of the bottom of the diversion tunnel was 54m, the same as the back of 6-level south drift. The detail of the diversion tunnel and the 6-S concrete plug is shown in Figure 12. This operation virtually stopped the inflow and the mine was ultimately dewatered and restored after interruption of production for a period of 10 months.

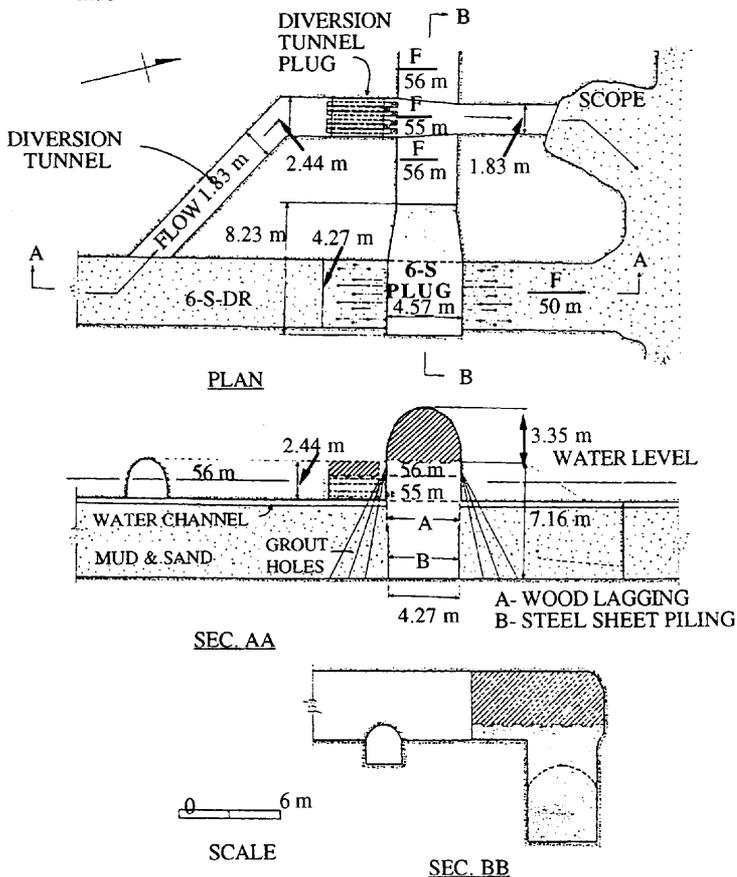
B: Details of the diversion tunnel and 6-S concrete plug

Figure 12 Details of access driftage to make a friction plug in 6 level south.
