Assessment of Atlin Ruffner Abandoned Mine, BC, Canada

Rob Dickin, Ryan Mills and Doug Bright

September 6, 2010

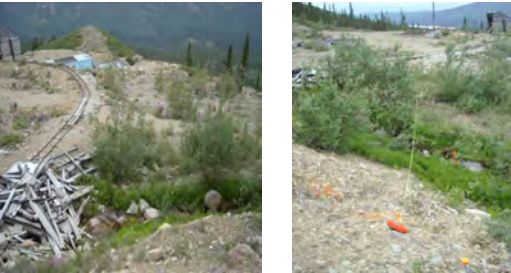
Adit Mine Water Discharge

- Mine adit discharge - reported to be deep borehole discharge in mine formerly used for Mill water supply
- Flows through sedimentation ponds then infiltrates into the ground within 100m
- Groundwater flow down slope 800m then discharges into large wetland
- Wetland has no surface discharge
- Wetland discharge re-infiltrates into thick glaciofluvial kame and kettle gravel deposits.

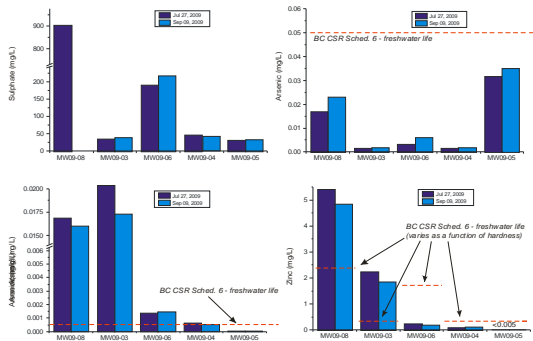
Groundwater Quality

- Substantial decrease in groundwater cadmium and zinc concentrations over distances of 100m.
 - Groundwater transport pathway between the major exposure area (Fourth of July Creek) and the Mill Site is largely inoperable.

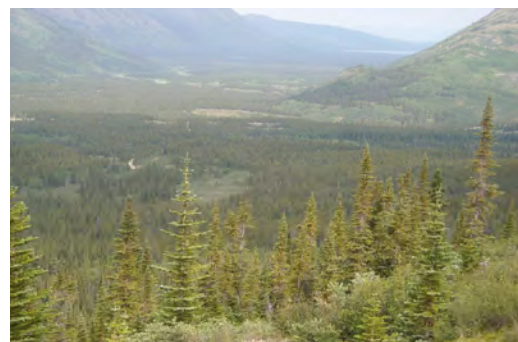
Surficial Geology and Aquatic Pathway

- Groundwater flows through thick, permeable gravel deposits for an additional 1.5 km to discharge into 4th of July Creek – the ultimate aquatic receptor.
- Natural system acts effectively as natural treatment system. Surface flow oxidizes metals and groundwater flow through gravel acts as a sand filter.
- Enormous potential for contaminant attenuation and dilution along flow path.
