Characteristics of Mine Water Inrush and Its Mechanisms — a Case Study in the Ganhe Coal Mine, Shanxi, China

Abstract Mine water inrush is a primary hazard in the process of coal mining, which is caused by various factors, complex processes and induced mechanisms, and studies on the spatiotemporal evolution of the processes and behavior of mine water inrush disasters may help determine their causes and effects. These studies may also provide an appropriate scientific basis for disaster prevention and control measures. Using a water inrush accident with a maximum flow rate of 730 m³/h and a stabilized rate of 300 m³/h, we studied its spatial and temporal characteristics, such as changes in the flow rate, the water level and the water quality following the inrush incident. We determined the phase characteristics of the water inrush process, which were divided into six stages. Based on the geological conditions, crustal stress conditions and hydrodynamic effects, a comprehensive analysis was performed to study the water pathway evolution near the F13 fault and evaluate the nonlinear evolution process from water seepage to water inrush. The research results revealed that the mechanism

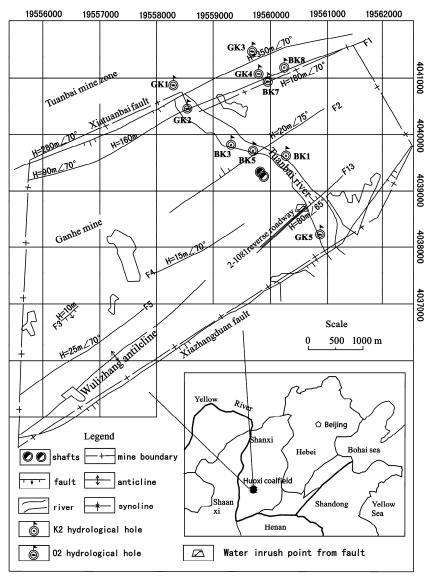
The whole Ganhe mine is exploited under high hydraulic pressure. The static water level of the Ordovician strata is +517 m, and the lowest elevation of seam $2^{\#}$ is -70 m. Therefore, the maximum water pressure is almost 5.9 MPa. There are four main aquifers in the coal-bearing sequence: K₈, K₉, K₂ and K₃. The former two aquifers are sandstone aquifers in the lower Shihezi Formation (P₁xs), whereas the latter two aquifers are limestone karstic fissure aquifers in the Taiyuan Formation (P₁t). Beneath the coal-bearing sequence, there are two Ordovician karstic fissure aquifers in the upper Fengfeng Formation and upper Majiagou Formation. Among the aquifers, the average thickness of the K₂ limestone is 9.11 m, and the water level is approximately 505 m, whereas the average thicknesses of the upper Fengfeng Formation and upper Majiagou Formation are 30 m and 60 m, respectively. There are 8 long-term observation boreholes for monitoring changes in the water level and temperature of the Ordovician and K₂ limestones (fig.1).

Fig. 1 Structures of the observation boreholesin the Ganhe coal mine.

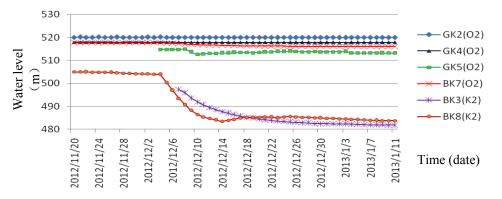
Water level elevation changes before and after the mine water inrush. The water levels observed from 6 effective boreholes are shown in fig.3.

Fig. 3 Curve of the water level with time in the observation boreholes.
