# Occurrence of coal seam as main aquifer

Haibo Bai, Hao Li, Dan Ma, Bin Du

## Abstract

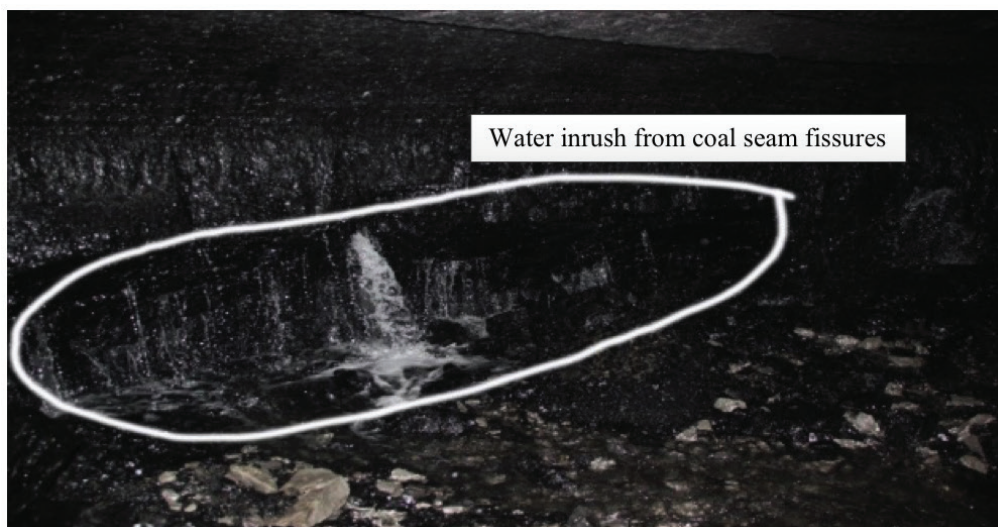
The afterwards occurrence of water inrush as excavating the roadways, maingates, tailgates, etc. fully proved that the No.2 coal seam was functioning as the main flooding aquifer. In April 6, 2012, when the return roadway came across the No. 2 coal seam, coal seam water burst into at an initial rate of  $90\text{m}^3/\text{h}$  and the inrush still increased with the further disclosing the coal seam. On April 26, 2012, the peak inrush went up to

$540\text{m}^3/\text{h}$ . As shown in Figure 1, high dip fractures with a common strike of North-South, where the water was running out, widely and intensively occurred in the No.2 coal seam, which further proved that the coal seam itself was the main flooding aquifer instead of other overlying or underlying weak aquifer.

*Figure 1 N-S to fractured water in the alley gang coal seam of the return ventilation roadway*

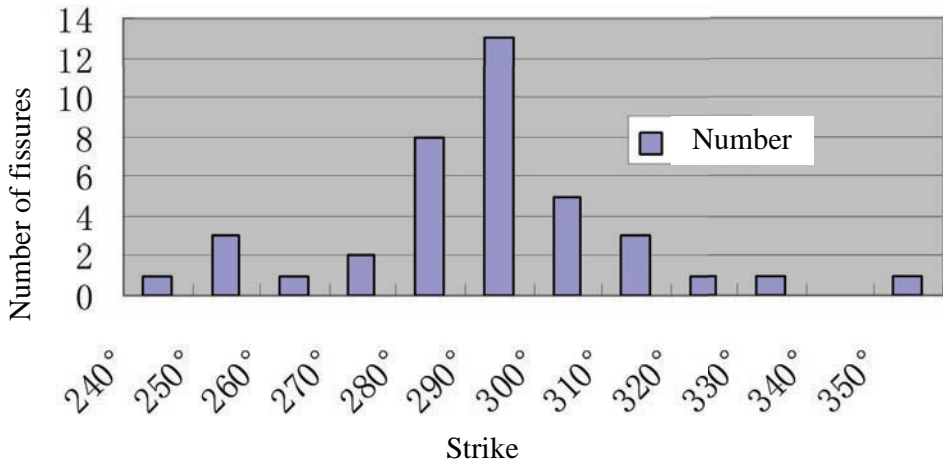
Figure 2 Observation statistics of effluent cracks in 11203 return airway

The fracture observation and statistics along the tailgates of Face 11203, as shown in Figure 2, indicated that inrush released from and flowed along two groups of water-conducting fractures with the strike of 10 $\approx$ 20 $^\circ$  and 285 $\approx$ 295 $^\circ$ , which were consistent with the regional neo-tectonic movement and stress field.

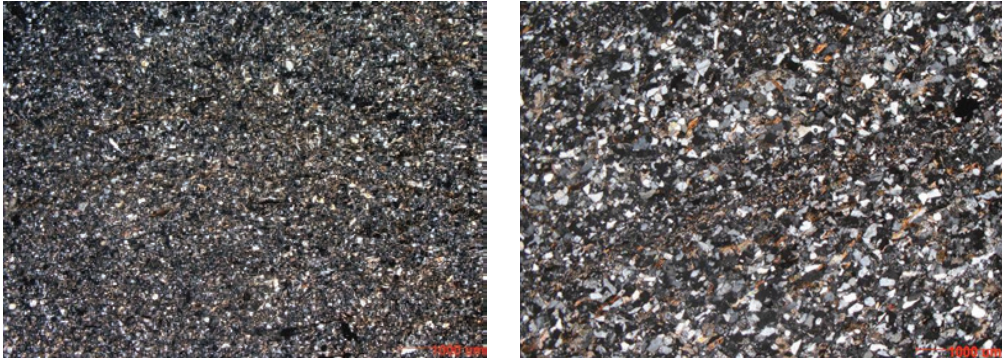
The sandstone of the roof and floor formations is mainly composed of grains of feldspar and lithic and clay fillings, which makes the fractures in the roof and floor strata almost closed and the whole roof and floor even serve as aquifuge (Figure 3). However, the unusually high strength, hardness and brittleness of coal seams makes it generate a large amount of open fractures.

*Fig. 3 Overlying clayey siltstone (left) and fine-grained lithic feldspar sandstone (right)*
