MINE WATER. GRANADA, SPAIN. 1985

**SURFACE PROTECTION PROBLEM IN CONDITIONS OF WATER
HAZARD IN DIAPIR SALT MINES**

Kortas Grzegorz and Wilk Jan,
Development Center for Chemical Raw Materials, Kraków,
and Jasiński Zbigniew, "Solno" Salt Mine, Inowrocław, Poland.

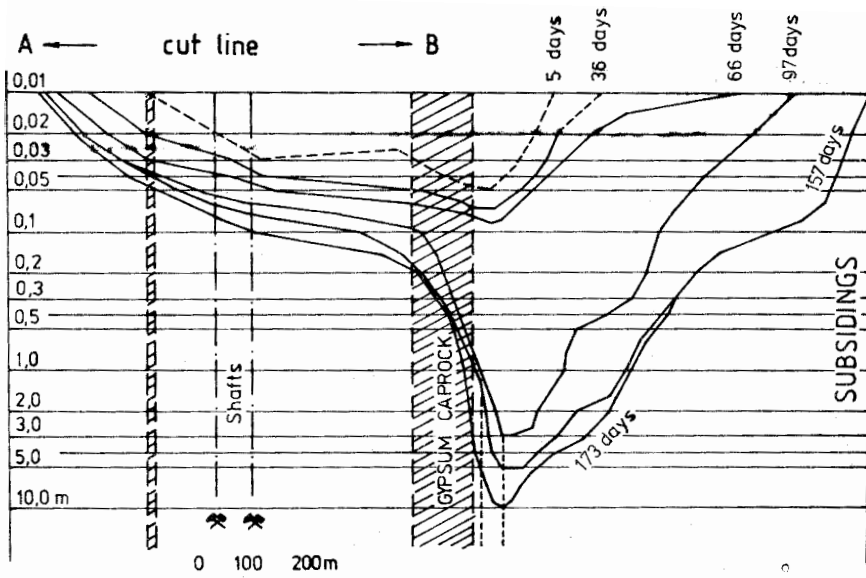
The bottom of the trough has lowered lately to 10 meters in the railway region (A. Rosikon, 1930) and a group of discontinuous, fault-like deformations (fig. 8) as well as fractures have appeared along directions of water run-off. Main terrain inclinations in the centre of the trough exceeded 15%. Final earth movements took place 175 days after the break-down, increasing the capacity of subsiding trough finally to 353 thousand cubic meters. Disposition of the subsiding trough is illustrated in fig. 6.

Fig. 6 Increases of subsiding trough in logscale

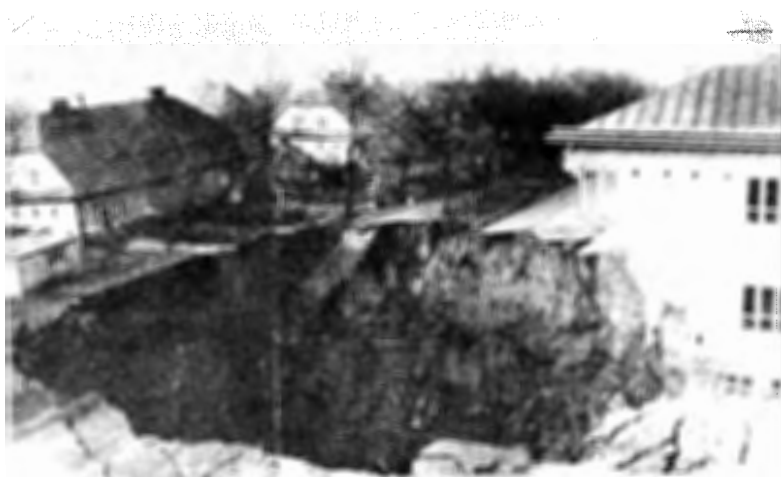
centre of the trough situated beyond the diapir, close to its boundary (fig. 5) 66 days after the break-down, the collapse sink appeared of a diameter amounting to 30 meters and 19 meters deep. (fig. 7).

Fig. 7 Photography of a collapse sink

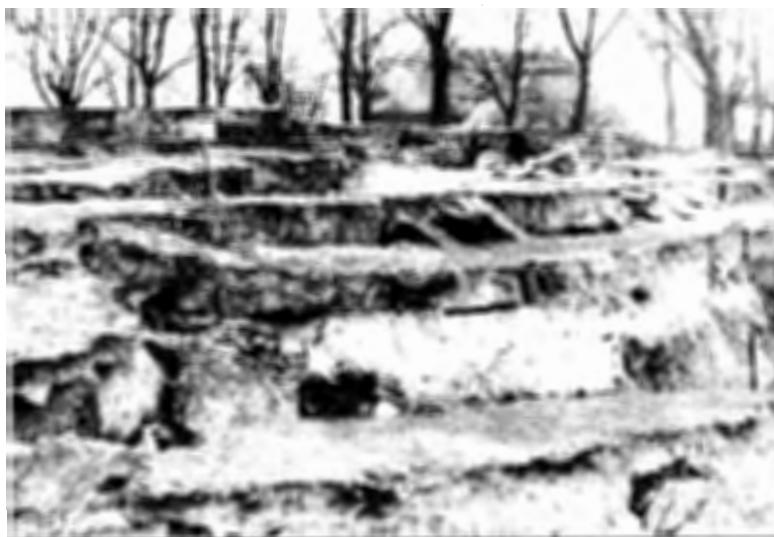
Fig. 8 Photography of discontinuous dislocations

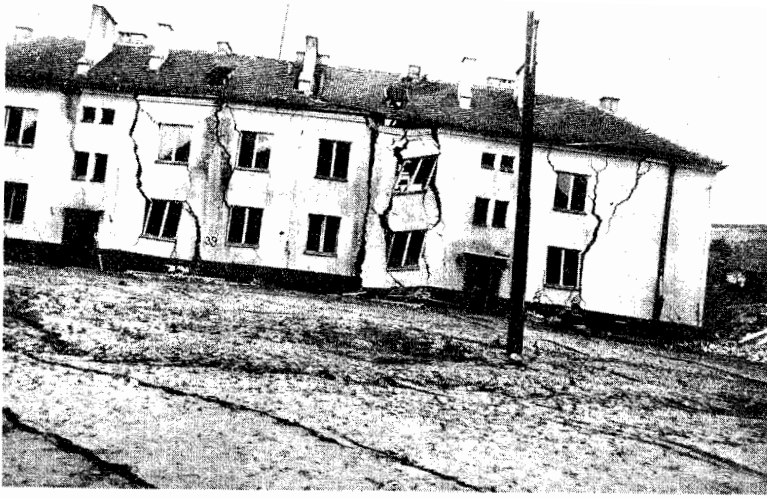
Fig. 9 Photography of damaged building

In the course of flooding of the mine the actual state of drainage was daily observed in 42 piezometers placed in both tertiary and gypsum cap formations and 16 piezometers installed in quaternary formations. The observation of surface movements was carried by recording the measurements in 300 bench-marks in monthly intervals, or once a week for chosen traverses. Wide and complex, geodesic and hydrogeological observations, systematically carried out and successively analysed made possible to evacuate safely 1340 people from 55 houses and stop both road and railway traffic in the right moment. In spite of great building damages (Fig. 9) no one of inhabitants of Wapno had been injured. Main mining damages came out on the area of 1,4 km², mostly beyond the salt diapir, where the inclinations exceeded 10%. 47 buildings were predestined for demolition. The restoration of hydrogeological equilibrium was proceeded by the reconstruction of railway and roads until the terrain was reconditioned. Buildings had been renovated and normal life in a housing estate had been restored.
