Remediation of the Gowrie Wash Plant, Port Morien, NS

By Dave Forrester, Mark King & Jeff Hilchey

Presentation to IMWA Symposium 2010
Cape Breton University, September 9, 2010

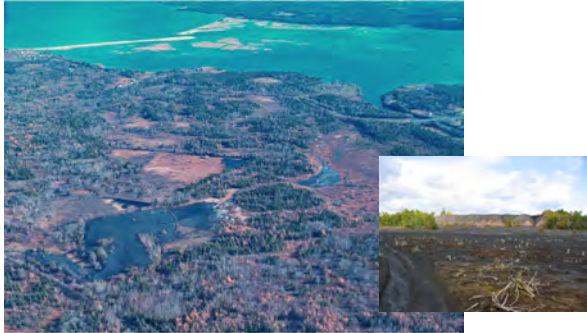
CHALLENGE

- 19TH Century coal industry left a legacy, not all positive, e.g. Gowrie Wash Plant a former central coal washing plant
- Operations were abandoned in 1897
- Left behind over 130,000 cubic metres of waste rock pile
- Slowly eroded and weathered over the years:
 - silting drainage courses
 - producing numerous seeps of acid rock drainage
 - with deep erosion channels
 - And coal fines accumulations around toe and
 - In a large natural wetland area located downstream
- AECOM scope: gap analysis, investigation, RAP, design

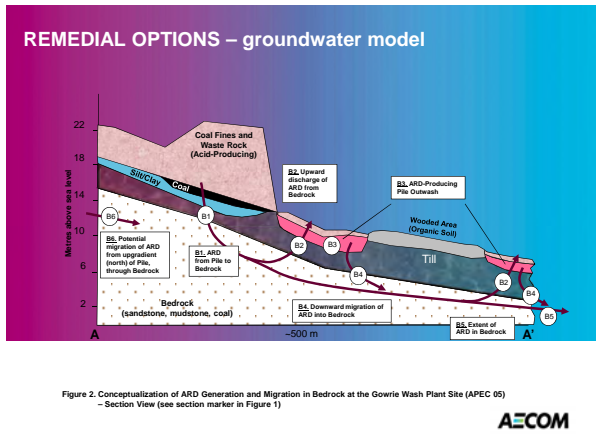
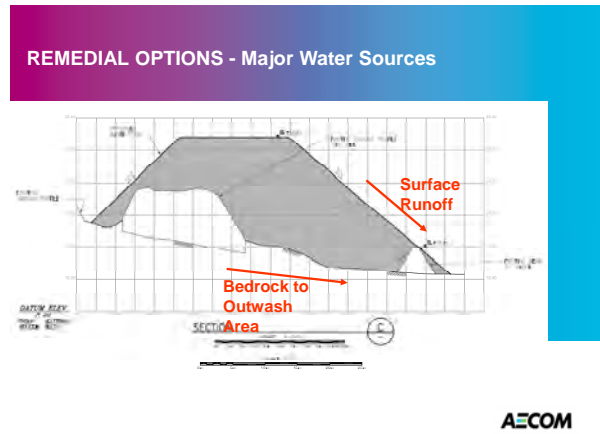
- **Central repository for 8 local sites,**
- **An engineered cap consisting of layers, btm up:**
 - a rough graded surface,
 - a 150 mm sand bedding layer,
 - a HDPE liner,
 - a geocomposite geonet drainage layer,
 - a 600 mm compacted till layer, top 25 mm soil
 - hydraulic seeding,
- **Surface water diversion channels,**
- **Settling ponds**
