Surface Water Management to Reduce Pollution at Dylife, Mid Wales

Abstract

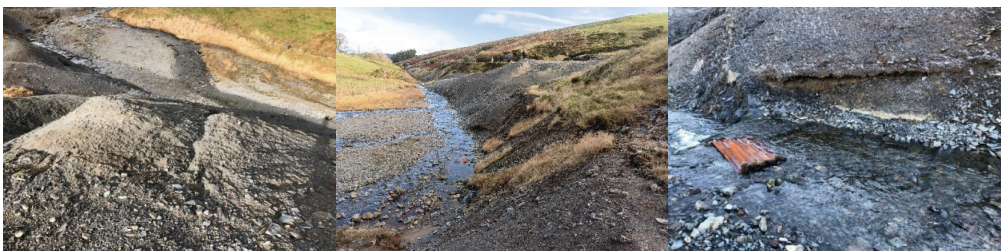
Figure 3, 4 & 5 Afon Twymyn looking downstream eroding Hirnant Tip toe.

Extensive monitoring, including source apportionment using salt dilution gauging and synoptic sampling has identified the remaining exposed dressing floor area and riverside spoil tips as major contributing sources of downstream metal pollution. The Twymyn channel is observed to directly erode spoil deposits and receive run-off from steep, gullied largely unvegetated slopes as the river traverses the main mine site and particularly as it runs directly along the toe of the Hirnant Tip within the eastern part of the designated Dylife Mine SSSI area (plates 1–3).

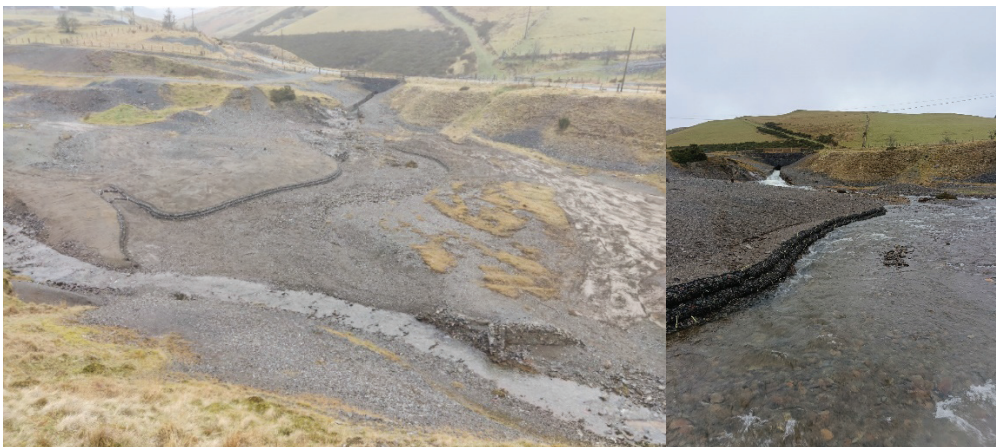
Figure 6 & 7 Erosion Protection Intervention in the Nant Dropyns Channel across the Former Dressing Floor, working in extreme wet conditions.

Due to the visible severity of the erosion and damage to vulnerable mine heritage features such as the bored wooden drainage pipes strapped with metal, early intervention measures were introduced. These used pre-filled 'rock roll' plastic mesh protection placed in front of the current eroded channel banks across the dressing floor and along the left-hand bank of the Twymyn that is subject to inundation and erosion during flooding (plates 4–5).
