Assessment of Atlin Ruffner Abandoned Mine, BC, Canada

Rob Dickin, Ryan Mills and Doug Bright

September 6, 2010

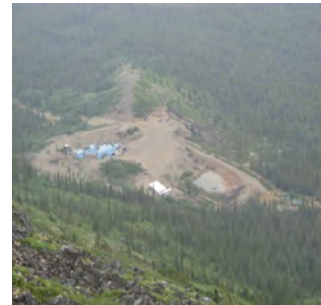
Mill Area Contaminant Sources

- Mill building
- Residual ore and waste rock
- Surface Soil
- Adit
- Tailings Impoundment
- Sedimentation Ponds

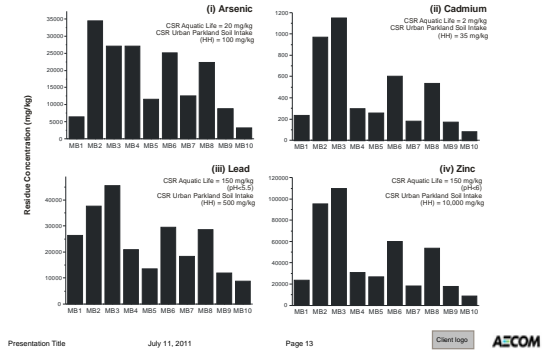
Summary of Metal/Metalloid Concentrations in Mill Complex Samples

Mill Building and Surficial Soil Contamination

- Permeable sand and gravel soils, deep water table
- High levels of arsenic and other metals in surface soils – inside and outside of building
- Small areas of spilled concentrate

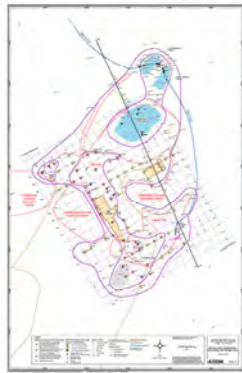
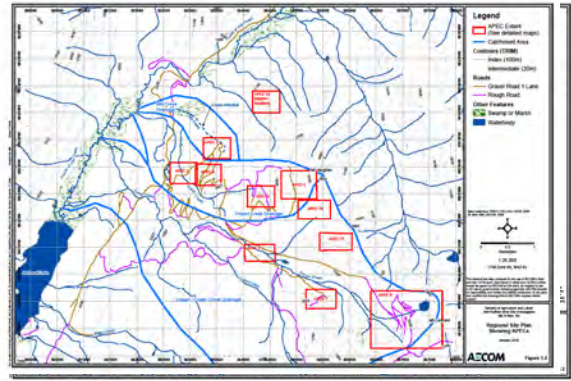
Mill Area Features

- Located on steep mountain slope in glaciofluvial gravel deposits
- Mine Adit with continuous mine water discharge – upper bench
- Mill – middle bench
- Tailings impoundment and sedimentation ponds – lower bench
- Drainage re-infiltrates into ground within 150m downslope of sedimentation ponds
